## GLASS PLANT AUDITS – THREE CASE STUDIES IN GLASS PRODUCTION PROBLEMS AND THEIR SOLUTIONS

J. M. Uhlik  
Toledo Engineering Company, Inc.  
Toledo, OH

### ABSTRACT

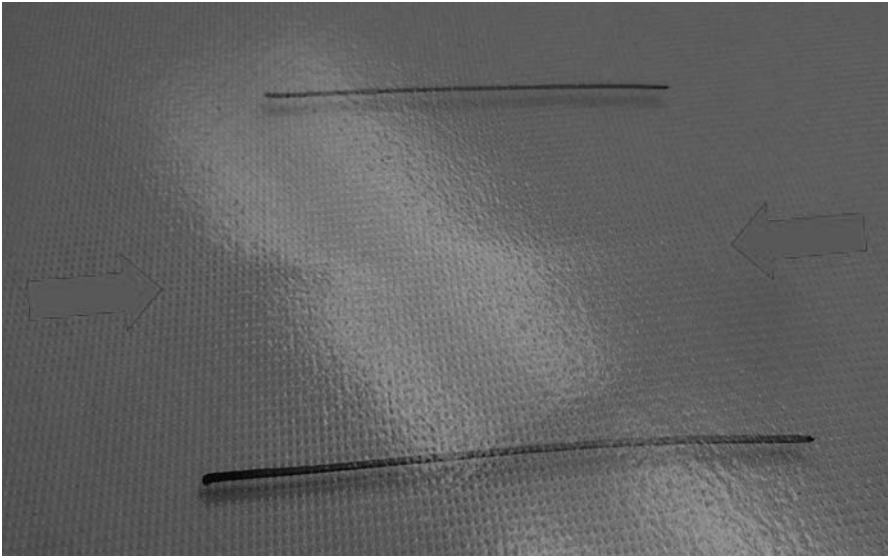
TECO was asked to assist with an increasingly evident non-conforming glass attribute from a throated furnace in Europe. The problem was a distortion line in the rolled glass sheet being called a "water mark" by plant personnel, which tested as a high density alumina-zirconia layer approximately 60-75 microns thick, shown below in Figure 1.

Figure 1. Optical inhomogeneity in the Ribbon

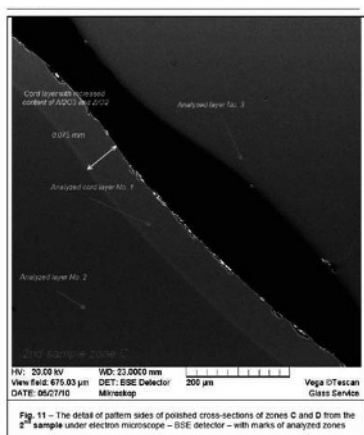
Figure 2. Analysis Results of the Glass Inhomogeneity.

Based on the analysis report, an average of five composition measurements yielded higher levels of alumina and zircon content than what was normally found in the base glass. Therefore, increased focus was placed on the batch, the glass furnace and the forehearth operation and structures, which had been previously been operated consistently and at steady state for some period of time.

Formula	Ox%
$\text{Na}_2\text{O}$	14,76
$\text{Al}_2\text{O}_3$	3,37
$\text{SiO}_2$	74,10
$\text{CaO}$	7,04
$\text{ZrO}_2$	0,74

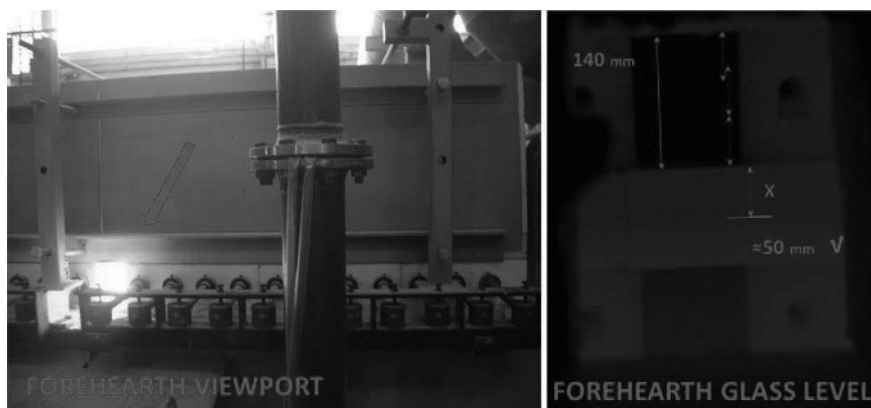
Figure 3. Forehearth Inspection Port and Forehearth Glass Level Estimate

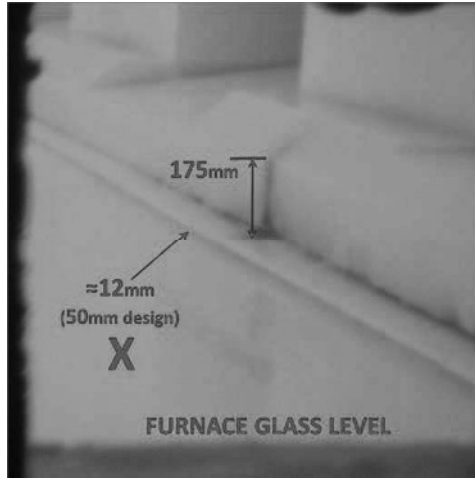
Finally, the inspection of the furnace interior provided that while the structure and superstructure refractory appeared to be in proper condition, the glass level as observed did not appear to be at the design level of 50 mm below top of block – there appeared to be much less glass freeboard, as shown in Figure 4. To check this observation, first a simple length of tubing was used as a water level, and when checked, showed that the furnace construction was correct, with both the furnace and forehearth top of block set to the same elevation. The actual glass level observation did not make sense, so not only was the water level used several more times, but an optical engineering level measurement was contracted locally, and these readings also verified the

Figure 4. Furnace Glass Level Visual Estimate

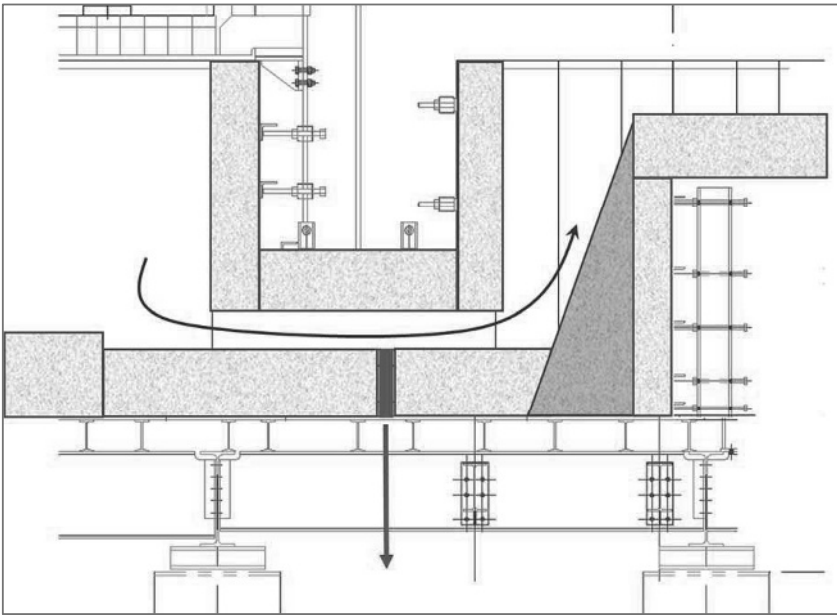
The distortion line in the glass was the presentation of this problem - a buildup of denser glass which restricted glass flow - and was solved by installation of a periodic drain capability in the bottom of the furnace throat, as shown in Figure 5.

Figure 5. Representation of a Sunken Throat Bottom Drain, such as by KTG Engineering.

Although seemingly improbable, a theory developed that perhaps there was restriction in the throat, possibly a buildup of denser glass that was ‘wicking off’ and presenting in the final product as the aforementioned watermark. The throat became the focus of the discussion, and a plan was developed to retrofit a drain onto the throat bottom, to remove a possible accumulated buildup of denser glass:

Plant management acted quickly to institute this solution. The results after draining the throat for a few hours, during which periods of inhomogeneous glass streaming were evident, was that the furnace glass level returned to the designed 50 mm below top of block. While seemingly improbable, an accumulation of denser glass in the throat area had slightly restricted the glass flow, requiring a higher furnace glass level and head pressure to maintain the operating glass level in the forehearth.

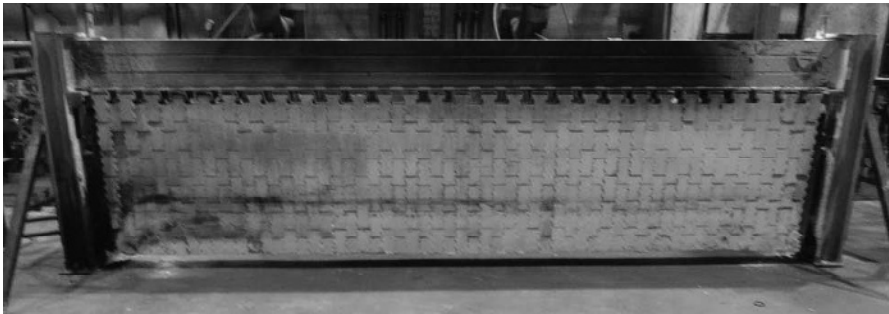
Figure 8. Old Replaced A Arch

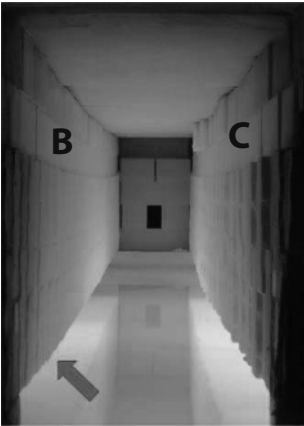
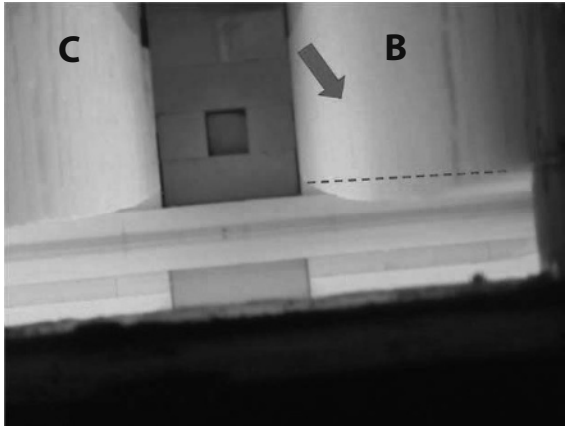
However, during the replacement of the A arch, the support structure of the B arch was exposed to higher temperatures and radiant heat from the open A arch area. This is normally acceptable for the short period of the A arch replacement procedure, in that the B waist arch support steel is designed to be water cooled. Unfortunately, the steel assembly provided by a local supplier had developed water leaks when originally placed in service, and the B arch support beam was necessarily switched over to compressed air cooling to avoid leaking water damage to the refractory structure. Periodic inspections of the B arch had shown only slight sagging (Figures 9 and 10) while being cooled with compressed air, and it had remained stable for several years.

Figure 9. View from Right Side

Figure 10. View from Left Side

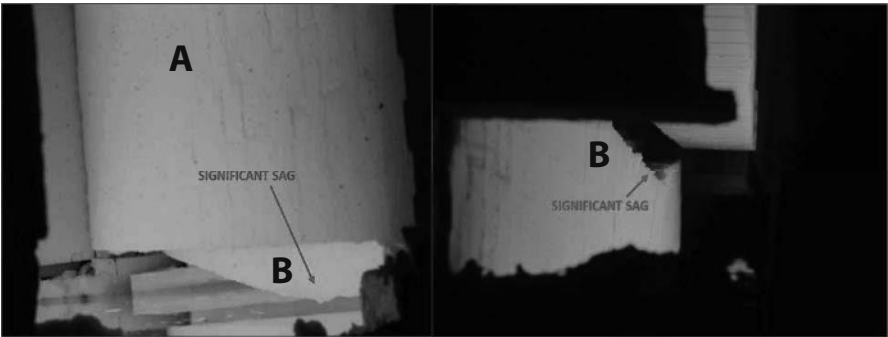
When the A arch was replaced, the B arch support was exposed, became overheated, and sagged severely during the replacement work, as shown in Figure 11. The B arch became a possible risk to the safe and efficient operation of the float glass process line going forward.

Figure 11. Views of the B Arch Maximum Sag during Replacement of the A Arch

With the discovery of the damaged B arch, TECO was asked to provide its expertise and participate in the emergency plan for the replacement of the B arch, which also supports an equipment access walkway above the arch. In general, this waist area is a fairly crowded space (see Figure 7 above). The new B arch refractory assembly had to be carefully preheated in order to sustain its introduction into the elevated temperature of its position in the furnace waist area. The procedure which was developed by the team was to transfer the new, preheated B arch into

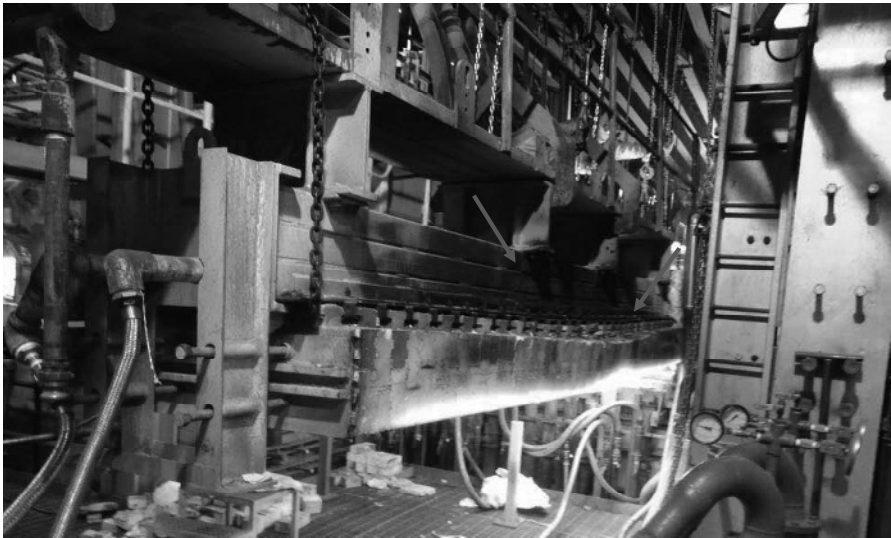
Figure 12. Old B Arch Removal from the Waist, with New B Arch being Set in Place from the Right Side

The new B arch was preheated in a temporary kiln built proximate on the operating floor, and when fully heated it was insulated, lifted out of the heating area, chained to the old B arch, and as the old arch was lifted and removed to the left, the new B arch followed from the right side into position. In Figure 12 below, the old B arch is shown when removed from the waist. The overheated area of the beam is evident in the center, as well as some of the permanent sagging of the refractory that resulted. Figure 13 shows the new B arch in place.

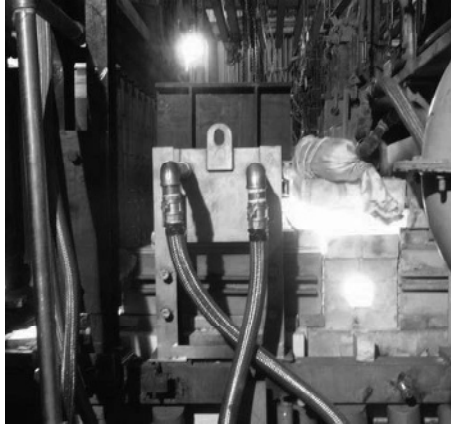
Figure 13. New B Arch in place, with Water Cooling

The procedure was executed quickly and efficiently as planned, resulting in a new, secure and stable refractory structure in the float furnace waist area. No further issues were reported afterwards.

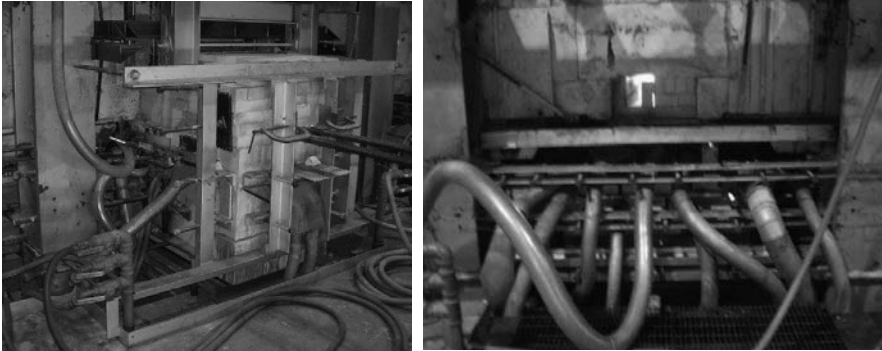
TECO was asked to assist a float glass manufacturer with the removal of the glass level bowls in their furnace design, when it was determined that these aging structures were highly worn and a source of glass loss. The physical removal work was to be performed during a routine maintenance hot-hold of the furnace. Working as a team, a concept was jointly developed and planned in detail.

Figure 17. Left: Left Side GLB before the Work; Right: Work Nearly Finished after its Removal

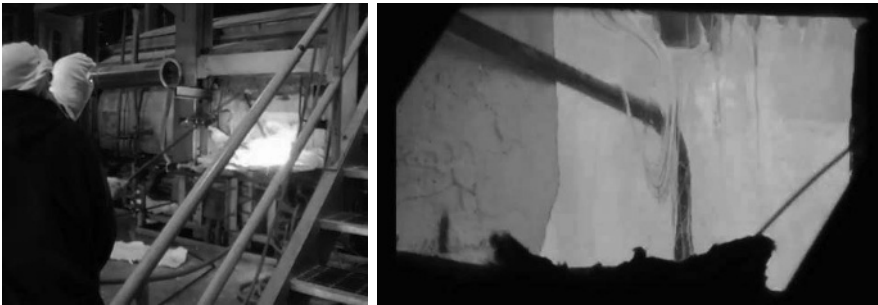
Figure 18. Left: First Water Lance Readied after GLB Superstructure Removed; Right: inserted (R)

To accomplish removal, a procedure to insert water lances directly into the molten glass was developed, in order to freeze the glass and secure the four to five-foot wide opening that was required. Water lances are used for similar applications in smaller furnaces, but this is atypical for a large float furnace containing approximately 1500 tons of molten glass. The application of the water lances also had to accommodate a clear working area for maximized personnel safety, and of course, facility protection from any molten glass leak. The steps of the work are highlighted in Figure 18.

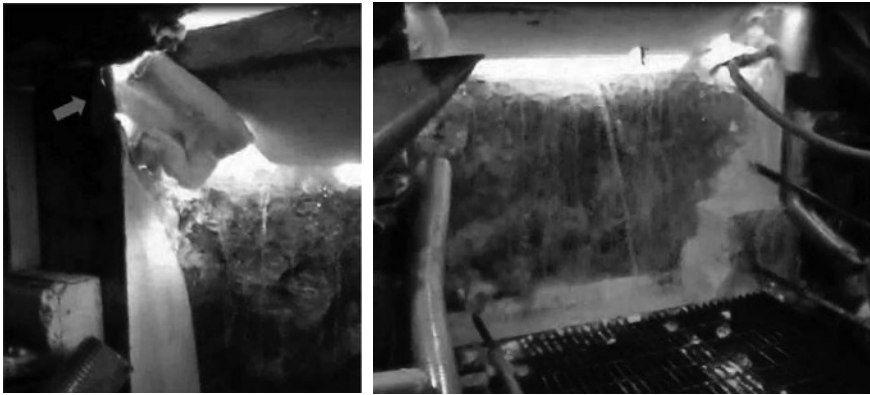
Figure 21. Left: Area of Concern in the GLB Furnace Inside Corner; Right: During Demolition. Bright orange spots of hot glass can still be seen on the right side.

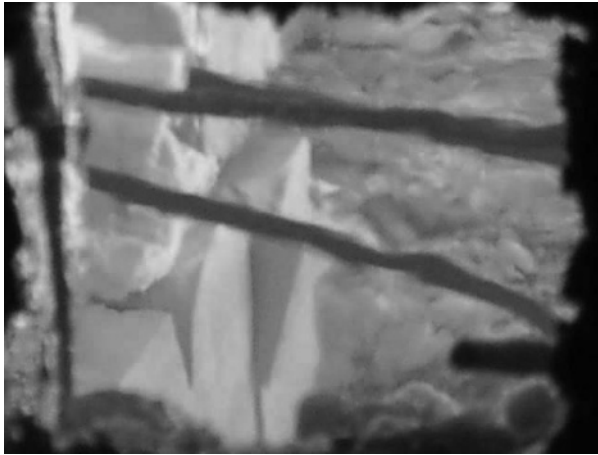
Figure 23. Interior View as Work Nearing Completion. Note: Due to the rapid exposure of the large tank wall block into the operating furnace high temperature environment, some block corner spalls occurred.

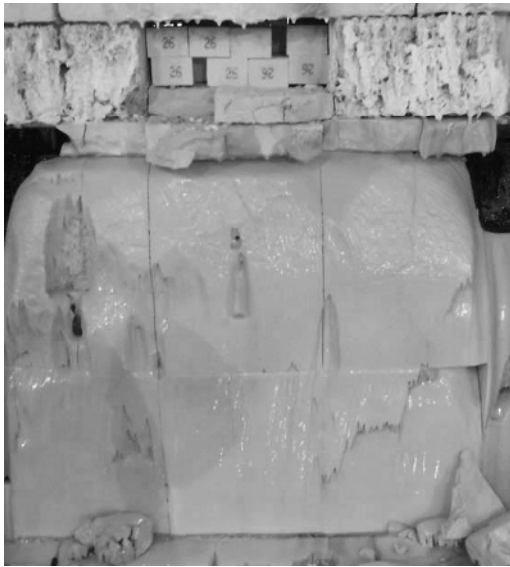
Figure 24. Secure Replacement Refractory (shown at cold repair inspection, after three full years of service)
