Subsea electrics – design for diagnosis and reparability

P MANE

Mobil North Sea Limited, Aberdeen, UK (a subsidiary of ExxonMobil Corp.)

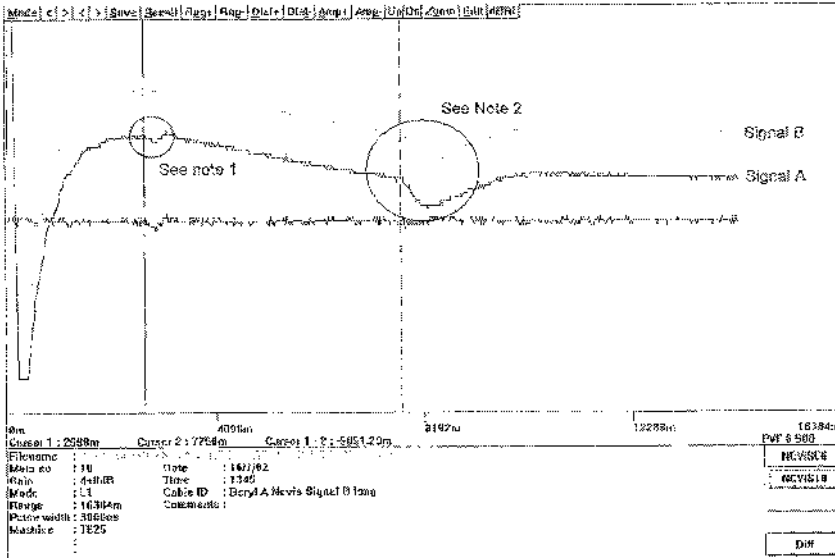
Figure 1.1.2 - TDR Trace for Signal A and B Lines

NOTE 1: Figure 1.1.2 shows a leakage in the A signal line at 2.6km, which could be a manufacturing splice or early signs of a defect.

NOTE 2: Figures 1.1.2 and 1.1.3 illustrate poor performance at the interface to the EDU with earth leakage being indicated.

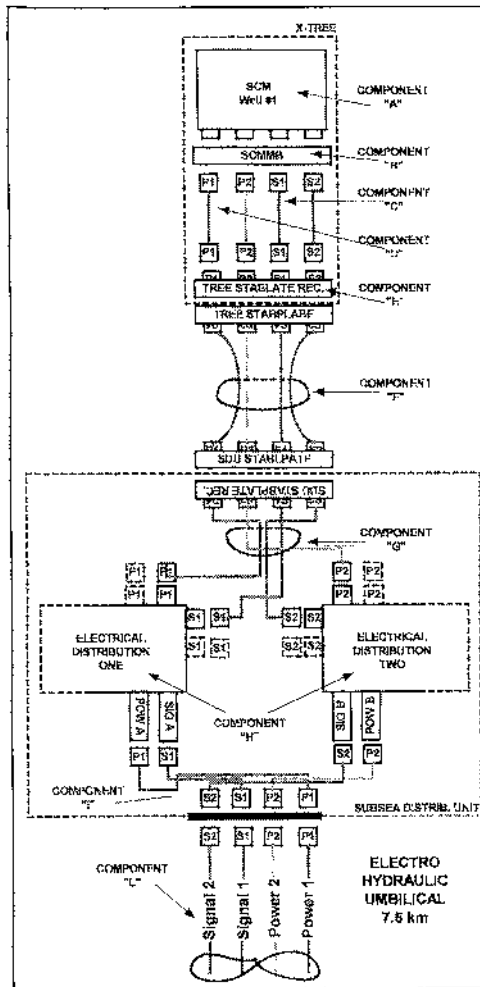
Figure 1.1.5 A "Well Branch" Electrical Schematic of Nevis

Taking a close look at the design of current typical EDUs, it can be found that most designs are based on connecting the "well branches" (refer to Figure 1.1.5) of the system in parallel. As in the example of the Nevis EDU, which is a common design for many subsea fields in the industry, it was required to test all of the branches one-by-one, going in a circle around the EDU, in order to find which branches were faulty. It is possible to minimise the number of tests by designing the EDU based on a cascade arrangement (refer to Figure 4.4.1). With a cascade arrangement, it is possible to localise the fault a lot faster, in fact it is possible to exclude half of the field components with a first test, with a second test, another quarter of components are excluded. The downside of this approach is that the number of connectors required to serve 12 wells significantly increases. Increasing the number of connectors, increases the number of failure points, the initial capital investment and the complexity of the electrical architecture. Although, this design is a valuable theoretical solution to decrease the time required to diagnose a complex field, it may not be practical for the reasons above therefore the importance of ensuring reliability through QA/QC should not be undermined. The use of this approach should be considered on a case-by-case basis, after a detailed costs benefit analysis has been conducted. Considering that the probability of an IR fault occurring should be minimal if quality control procedures and rigorous testing are strictly adhered to, it is suggested that the right reliability balance is found. Adding only one extra connector reduces the time for diagnosis by half; after this the law of diminishing returns applies. Depending on the field size, it should be possible to define an optimum cascade level. Regardless of the EDU design chosen for the field, the designer should consider allowing for possible future interventions.

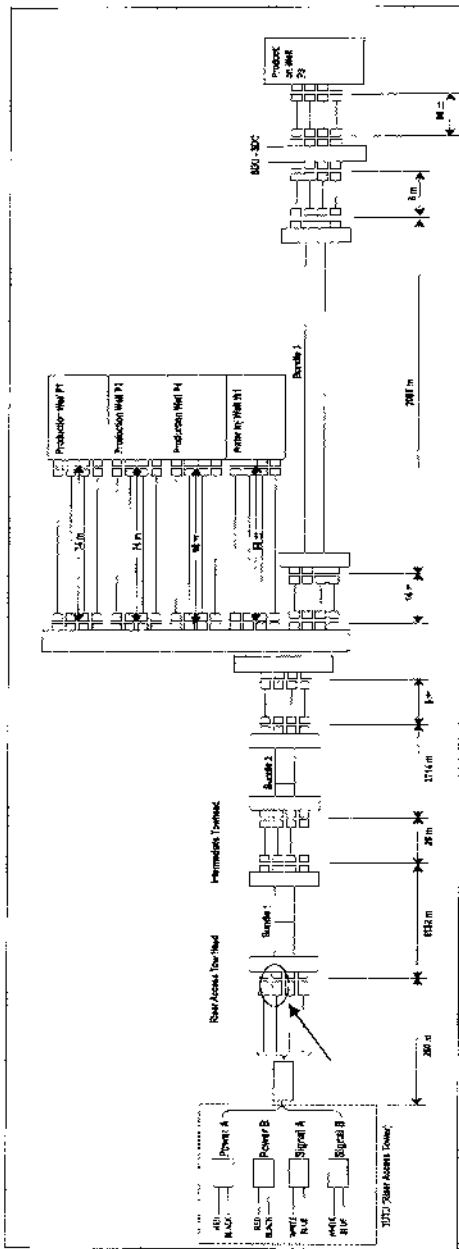
Figure 1.2.2 - Electrical Schematics Buckland Field

Installed in 1998, 12.5km from the host platform, this five well development is in 110m water depth. The control system is based on a short 300m electro-hydraulic umbilical that takes the controls from the platform to the bottom of the riser to interface with a pipeline bundle. As in the case of the Nevis field, two power and two signals lines are present. In this case Power B had completely failed in 2002, with the system continuing to operate on Power A alone (refer to Figure 1.2.2).

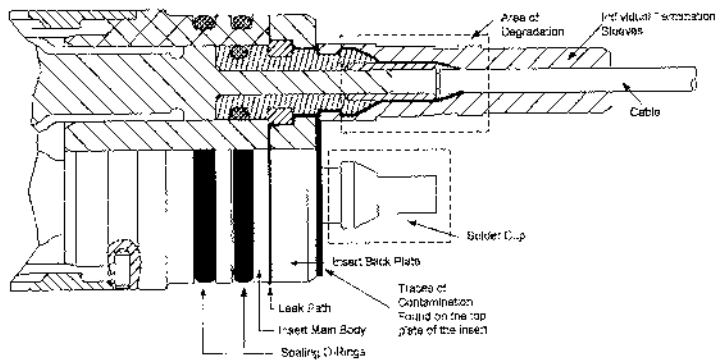
Figure 2.1.5 Insert Assembly Section Drawing - No housing shown

Figure 2.1.5 shows the leak path of the solvent contaminant, which with time, break the oil molecules and migrate through the interfaces of the insert following the contours and reaching the solder cup.

In conclusion, it was found that the cause of failure was a conductive deposit (refer to Figure 2.1.5, interface between main insert plate and back insert plate 'red line' and on top plate 'blue line') on the connectors assembled by the supplier (potentially from the dielectric fluid used to protect the cables or an extensive amount of flux or degreaser used during assembly). The cause of failure was most likely the way the connector was terminated to the cable, as it is unlikely that the dielectric fluid itself is the cause of the fault.

The subsea connector manufacturer recommendation was that the connector be placed horizontally in a vice for soldering and a special type of degreaser and solder be used for the soldering of the joints. Moreover, since the initial connectors were made the subsea control system manufacturer no longer uses dielectric oil to fill the enclosure, and it is now recommended (by the connector manufacturer) to use silicon to fill the back of the connector.
