# *Failure Analysis*

## **I. INTRODUCTION**

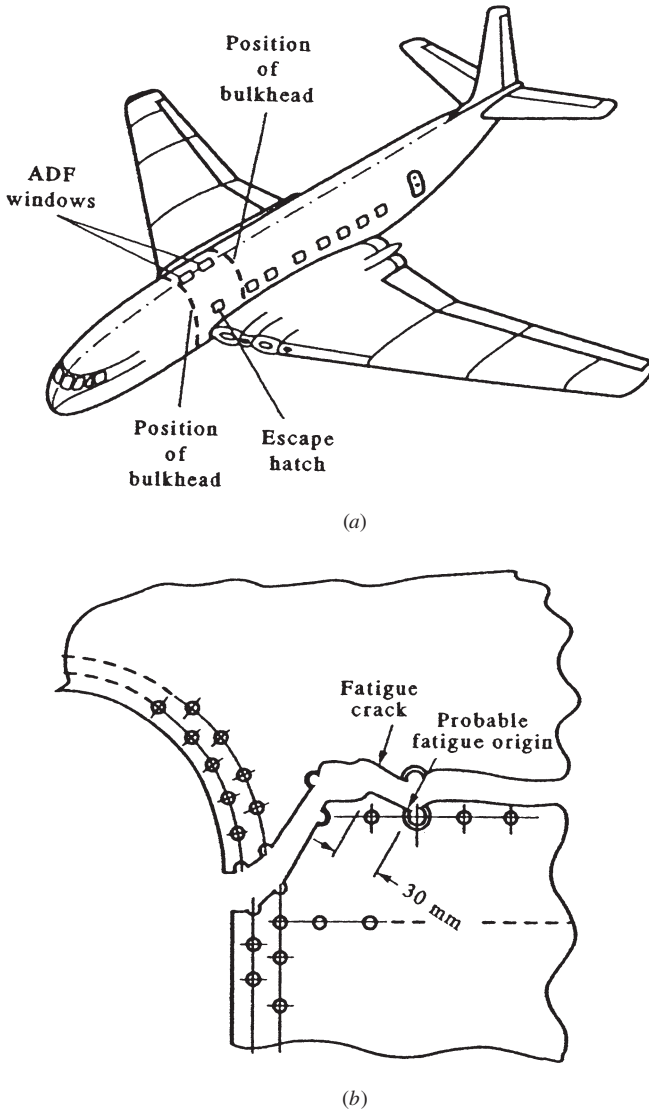
**2. Comet Aircraft Crashes** In the early 1950s, the Comet aircraft was the first jet transport introduced into commercial passenger service. The plane was so superior to propeller-driven transports that it soon captured a large share of the market for future transport planes. However, not long after coming into service, two planes of the Comet fleet, on climbing to cruise altitude, underwent explosive decompressions of the fuselage (as shown by subsequent investigation), which resulted in the loss of the planes as well as the lives of all aboard. Intensive investigation revealed that these crashes were due to fatigue cracking of the fuselage at regions of high stress adjacent to corners of more-or-less square (rather than round) windows, as shown in Fig. 1-2. The fatigue loading was due to the pressurization and depressurization of the cabin, which occurred in each takeoff and landing cycle. The presence of fatigue cracking was confirmed through study of the fracture surfaces of critical parts of the wreckage. These surfaces were found to contain fractographic markings, which are characteristic of fatigue crack growth (4).

**Fig. 1-2.** (a) The Comet aircraft. (b) The location of fatigue cracking near an aft corner of the ADF (automatic direction finder) window. (After Jones, 3, reprinted by permission.)

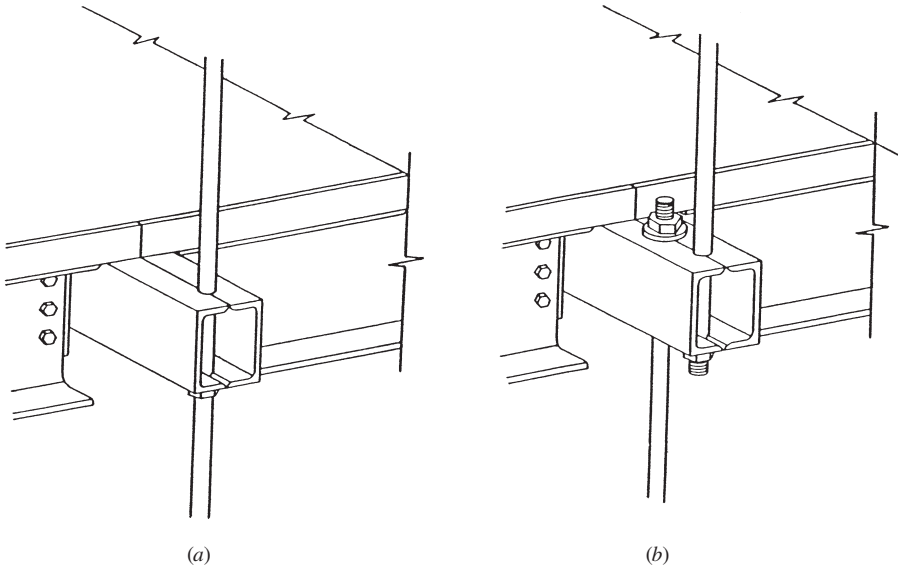
However, during construction, drawings were prepared by the steel fabricator that called for discontinuous rather than continuous hanger rods, Fig. 1-3b. In this modified design, three pairs of hanger rods extended from the fourth floor box beams to the roof framing, and three pairs of hanger rods extended from the second floor box beams to the fourth floor box beams. Under this arrangement, all of the second floor walkway load was first transferred to the fourth floor box beams, where both that load and the fourth floor walkway load were transmitted through the box beam hanger rod connections to the ceiling hanger rods. This change essentially doubled the load to be transferred by the fourth floor box beam-hanger rod assembly connections.

**Fig. 1-3.** A comparison of the Kansas City Hyatt walkway connectors. (a) As originally designed. (b) As built. (From National Bureau of Standards, 8.)

Postcollapse failure analysis indicated that the failure of the walkway system initiated in one of the box beam-hanger rod connections. In this instance, the fabricator, structural engineer, and the architect, each of whom had approved the design change, had not appreciated the consequences of the design change.

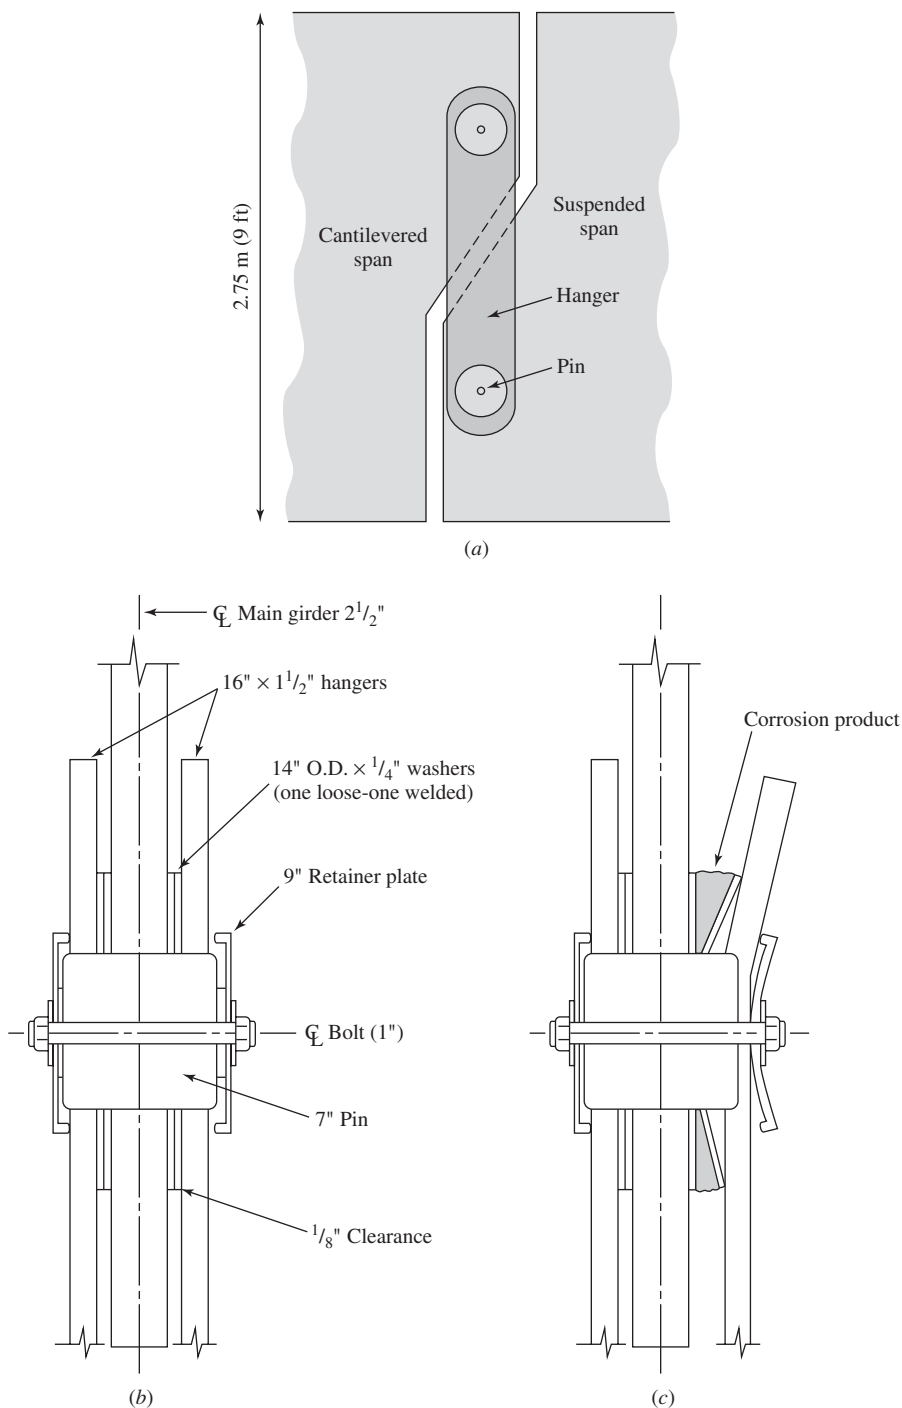
**Fig. 1-4.** The Myannis River bridge hangers. (a) Method of supporting failed suspended span. (b) Pin-hanger assembly as built. (c) Pin-hanger assembly after 24 years of service. (Fig. 1-4 b and c, after Demers and Fisher, 9.)

components of the bridge. Collapse started at the southeast corner as deduced from the postfailure position of the span. After the collapse, the southeast corner inside hanger was found to be straight and attached to the upper pin, whereas other connectors had been severely deformed. It was concluded that since the inside hanger was straight, the lower pin had separated from it prior to the collapse and had moved in the direction of the outer hanger. This unloading of the inner hanger doubled the load on the outer hanger. The resulting high bearing pressure at the upper surface of the upper pin led to the formation of a fatigue crack in the pin, which caused a portion of the upper pin to separate from the pin, thereby allowing the hanger to slip off the upper pin to bring about the final collapse of the span.

Postaccident inspection revealed that the bearing surface of the southeast corner inside hanger at the lower hole was severely corroded. The inside end of the lower pin was severely corroded and tapered, and the bottom edge had broken off. Movement of the lower pin required the failure of the restraining bolt through the pin. Extensive corrosion packout (compare Figures 1-4*b* and 1-4*c*) between the outer washers was found on the outer side of both upper and lower assemblies, which resulted in plastic deformation of the retainer plate and high tensile stresses in the bolt, which led to its fracture. It was concluded that failure was the result of a progressive process that occurred over a period of time, and that corrosion packout was primarily responsible for the hanger displacement on the pin, which led to the collapse.

This failure underscored the importance of maintaining effective corrosion prevention and inspection programs to maintain the integrity of such structures.

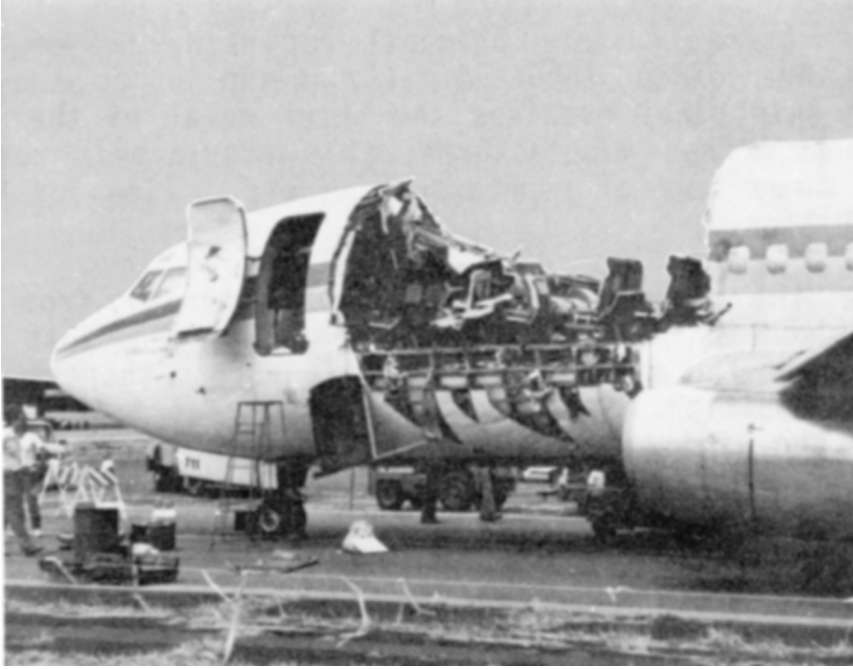
**7. Aloha Airlines Boeing 737-200 Accident (10)** In 1988, a Boeing 737-200 operated by Aloha Airlines, while en route from Hilo to Honolulu, HI, experienced an explosive decompression and structural failure as the plane leveled at 24,000 feet. Approximately 18 feet of the cabin skin and structure aft of the cabin entrance door and above the passenger floor had separated from the airplane, Fig. 1-5. There were 89 passengers and 6 crewmembers on board. One flight attendant was swept overboard and seven passengers and one flight attendant received serious injuries. An emergency landing was made on the island of Maui. As a result of the accident the airplane was damaged beyond repair and was dismantled and sold for scrap.

**Fig. 1-5.** General view showing the damage sustained by the Aloha Airlines 737. (From NTSB, 10.)

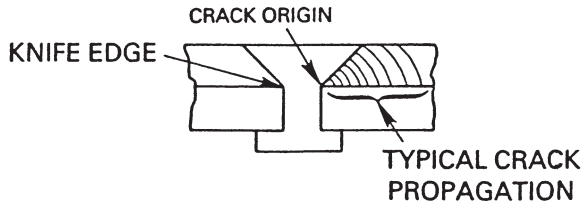
countersunk rivets. Fuselage hoop loads were intended to be transferred through the bonded joint, rather than through the rivets, allowing for thinner skin with no degradation in fatigue life. However, early service history with production B-737 airplanes revealed that difficulties were encountered with the bonding process, and it was discontinued after 1972. In order to safeguard those B-737 planes that had been “cold bonded,” Boeing issued a number of service bulletins over a period of time directing the attention of operators to the problem of disbonding and providing information on how to check for disbonding using the eddy current nondestructive examination (NDE) method. In 1987, the FAA issued an airworthiness directive (AD) requiring that eddy current inspections of the bonds and repairs, if needed, be carried out in compliance with the Boeing service bulletins. Some of the bonds had low environmental durability, with susceptibility to corrosion. Some areas of the lap joints did not bond at all, and moisture and corrosion could contribute to further disbonding. When disbonding did occur, the hoop load transfer through the joint was borne by the three rows of countersunk rivets. However, the countersinking extended through the entire thickness of the 0.036-inch sheet, which resulted in a knife edge being created at the bottom of the hole, which concentrated stress and promoted fatigue crack nucleation, Fig. 1-6. For this reason, fatigue cracking would be expected to begin in the outer layer of the skin along the lap joint along the upper, more highly stressed, row of rivet holes.

**Fig. 1-6.** A sketch of a countersunk rivet and an associated fatigue crack observed in Aloha Airlines 737. (From NTSB, 10.)

The NTSB believed that the top rivet row was cracked at the critical lap joint before the accident flight takeoff, and determined that the probable cause of the accident was the failure of the Aloha Airlines maintenance program to detect the presence of the significant disbonding and fatigue damage that ultimately led to the failure of the lap joint and the separation of the fuselage upper lobe. This accident was significant in that it brought attention to some of the corrosion and fatigue problems that could develop in *aging aircraft*. It also focused attention on the problem of multiple-site damage (MSD), that is, the formation and possible linking up of fatigue cracks formed at adjacent rivet holes.

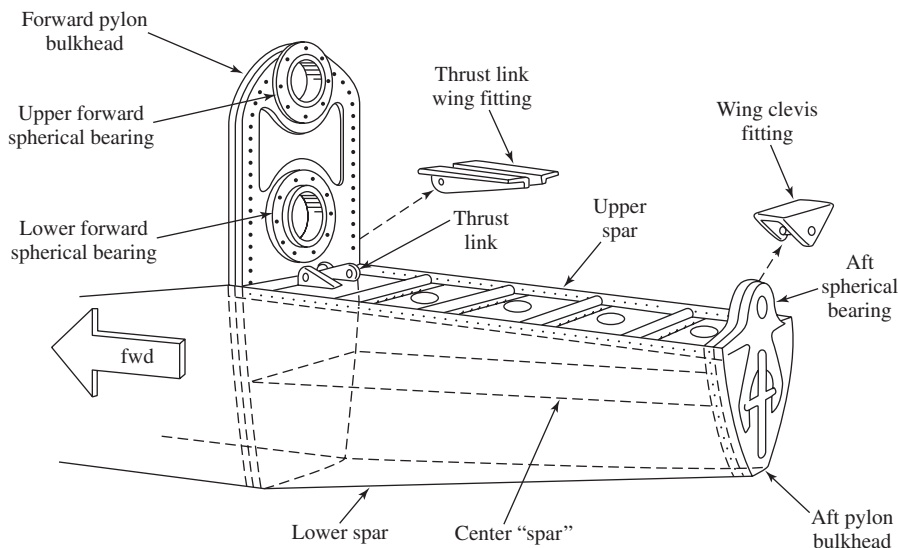
**Fig. 1-7.** The pylon assembly of a DC-10. The upper spars and sheet metal are attached to the critical forward flange of the aft bulkhead. (From NTSB, 11.)

Postaccident investigation revealed that a portion of the upper forward flange of the aft bulkhead had been fractured by overload in the inboard-outboard direction just forward of the radius between the flange and the bulkhead plane. The fracture had been initiated by a downward bending moment at the center section of the flange just forward of the fracture plane due to contact between the clevis and the flange. As a result of this contact, the aft fracture surface of the upper flange was deformed into a crescent shape that matched the shape of the lower end of the wing clevis. The length of this overload fracture was 10 inches. Fatigue cracking was present at both ends of the overload fracture, and the total length of the crack due to both overload and fatigue was 13 inches.

The structural separation of the pylon was caused by a complete failure of the forward flange of the aft bulkhead after its residual strength had been reduced by the fracture induced during the maintenance operation as well as by additional fatigue crack growth in service. It is also clear the poor communications between engineering and maintenance personnel, and between the FAA, the manufacturer, and the airlines contributed to this accident.

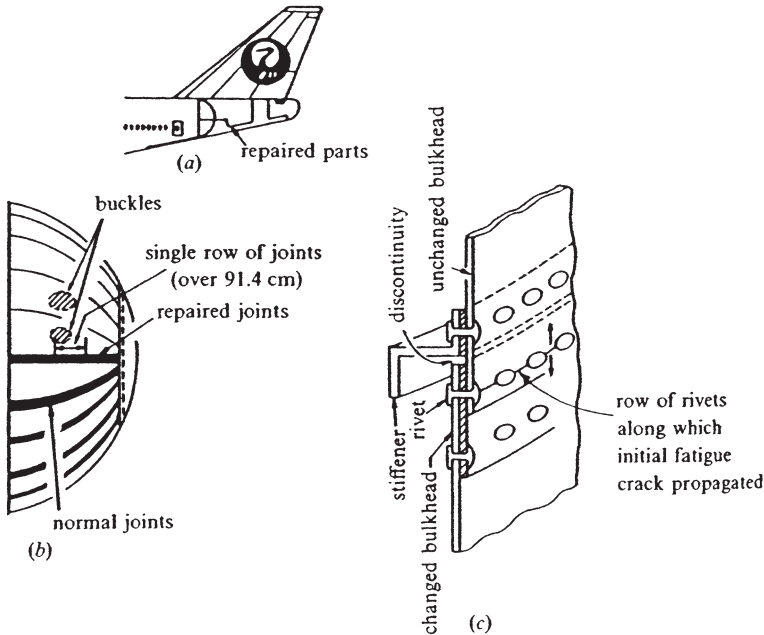
This aircraft had been in a takeoff mishap in June of 1978 in which the tail section struck the runway, causing damage to the lower half of the rear pressure bulkhead. This bulkhead is in the shape of a hemisphere and is made of thin-gauge aluminum alloy sheets. At a joint between sheets the sheets overlap, and an additional piece of sheet material, known as a doubler, spans the riveted joint to provide extra strength. To repair the damage after the 1978 accident, a new lower half bulkhead was riveted to the upper half. However, the two halves were not properly spliced together. On the upper side of the joint, there was a doubler and a stiffener on the inner side of the bulkhead, Fig. 1-8. On the lower side of the joint there was a doubler, but the doubler was not continuous with the upper doubler, so that a gap existed between the doublers, with only the sheet material carrying the load. In addition, the centroid of the load-bearing material was now on the inner side of the bulkhead. Therefore, the load on the sheet spanning the gap consisted not only of that due to the hoop tension, but also that due to bending because of the eccentric loading condition created by the doublers and the stiffener. Each time the cabin was

Fig. 1.8. The rear bulkhead of the JAL 747 SR. (After Kobayashi, 12.)

pressurized, there was an increase in stress in the aluminum sheet spanning the gap over that expected. As a result of this stress increase, fatigue cracks were formed at each of the rivet holes on the lower half of the bulkhead just below the gap, another example of MSD. These fatigue cracks eventually linked up, and the resultant long crack led to the explosive decompression.
