## GLASS PLANT AUDITS – THREE CASE STUDIES IN GLASS PRODUCTION PROBLEMS AND THEIR SOLUTIONS

J. M. Uhlik  
Toledo Engineering Company, Inc.  
Toledo, OH

### ABSTRACT

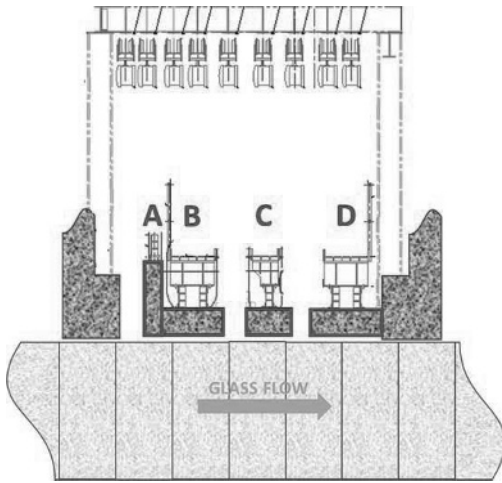
Figure 6. Layout of Waist Arches A through D

TECO was asked to assist a float glass manufacturer who had recently changed a large refractory structure in the waist area of their float furnace, to relieve a possible source of refractory contamination in their glass ribbon. In normal circumstances, this should be a straightforward procedure, the replacement of the A arch (see Figures 6 & 7 below).

The A arch, as can be seen in the Fig. 1, is a high and narrow design that helps shield the downstream area of the waist during normal openings of the upstream access area, in front of A, for routine maintenance in that area. The old A arch, replaced by the customer, is shown in Figure 8.

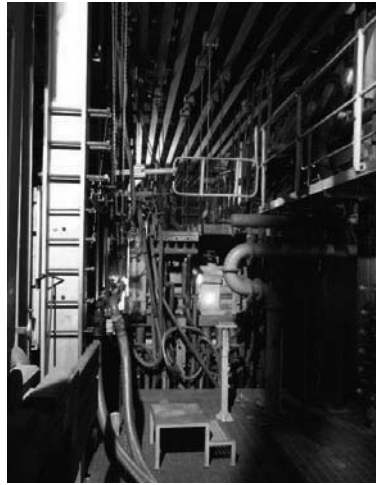
Figure 7. View of Waist, Right Side

With the discovery of the damaged B arch, TECO was asked to provide its expertise and participate in the emergency plan for the replacement of the B arch, which also supports an equipment access walkway above the arch. In general, this waist area is a fairly crowded space (see Figure 7 above). The new B arch refractory assembly had to be carefully preheated in order to sustain its introduction into the elevated temperature of its position in the furnace waist area. The procedure which was developed by the team was to transfer the new, preheated B arch into

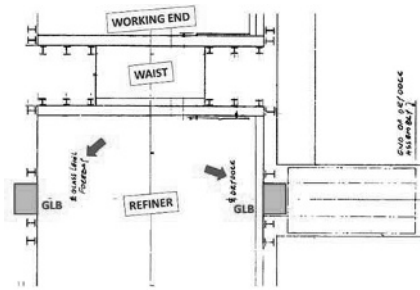
Figure 14. Typical Position of GLB Shown in an Old Furnace Drawing

TECO was asked to assist a float glass manufacturer with the removal of the glass level bowls in their furnace design, when it was determined that these aging structures were highly worn and a source of glass loss. The physical removal work was to be performed during a routine maintenance hot-hold of the furnace. Working as a team, a concept was jointly developed and planned in detail.

Glass level bowls (GLB) have been built into furnaces in the past, primarily for the utilization of nuclear level detectors, and even farther in the past, as a structure called a dry dock alcove when ceramic floaters were used in the waist as a skimmer, prior to the adoption and use of water cooled waist pipes, as shown in Figures 14 and 15. As can be seen in Figure 16 below, the GLBs do not contain the full depth of the glass, however, their removal and replacement with standard height furnace sidewall refractory, meant that the entire depth of the molten glass in the furnace would be exposed, and therefore needed to be reliably constrained.

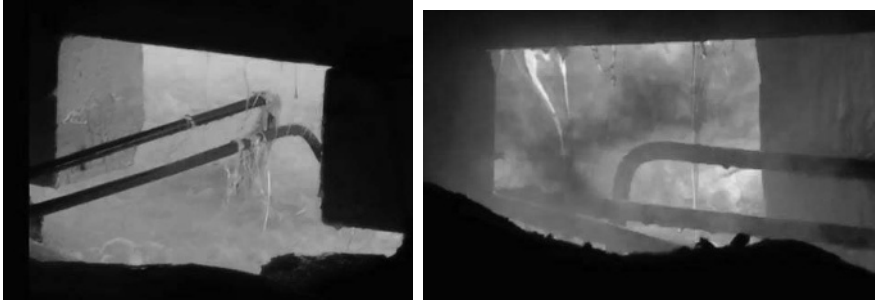
Figure 19. Second (L) and Third Lances (R) When Initially Placed

As a result of water being introduced directly into the molten glass depth, the steam being produced initially caused significant eruptions and displacement of the normally calm glass surface. The area of glass in the furnace in front of the GLB was monitored and evaluated for the planned for amount of cooling required to stabilize the area in order to contain the furnace molten

glass and allow complete removal of the GLB and lower furnace sidewall blocks in this area. Once judged secure, the demolition was completed. These steps are presented in Figures 19 – 21.

To accomplish removal, a procedure to insert water lances directly into the molten glass was developed, in order to freeze the glass and secure the four to five-foot wide opening that was required. Water lances are used for similar applications in smaller furnaces, but this is atypical for a large float furnace containing approximately 1500 tons of molten glass. The application of the water lances also had to accommodate a clear working area for maximized personnel safety, and of course, facility protection from any molten glass leak. The steps of the work are highlighted in Figure 18.
