# 1

## Introduction

## 1.2 Hydraulic Fracturing

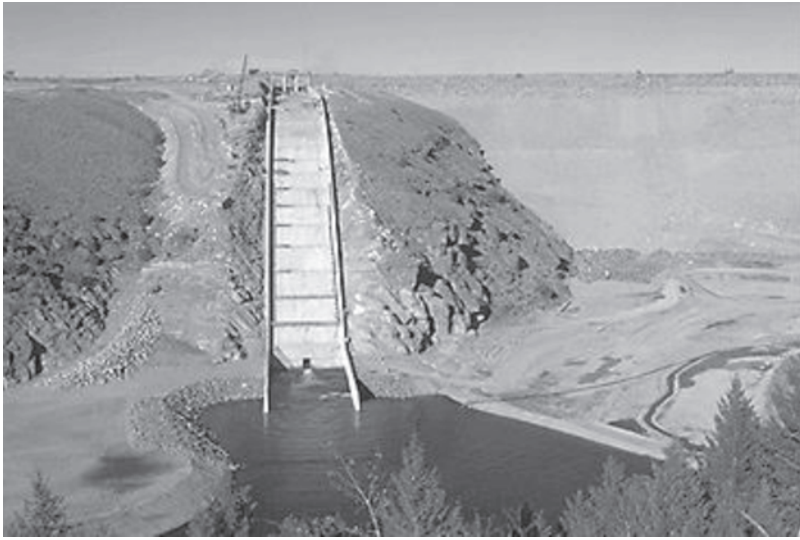
**Figure 1.1** View of the Teton Dam and its spillway. (Reproduced with permission of U.S. Department of the Interior)

The dam (see Figure 1.1) was completed in November 1975 and no seepage was noted on the dam itself before the date of the collapse. However, on 3 June 1976, workers found two small springs had opened up downstream. At the time of the collapse, spring runoff had almost filled the new reservoir to its capacity with a maximum depth of 73 m. Water began seeping from the dam on the Thursday before the collapse, an event not unexpected for an earthen dam. The only structure that had been initially prepared for releasing water was the emergency outlet works, which could only carry

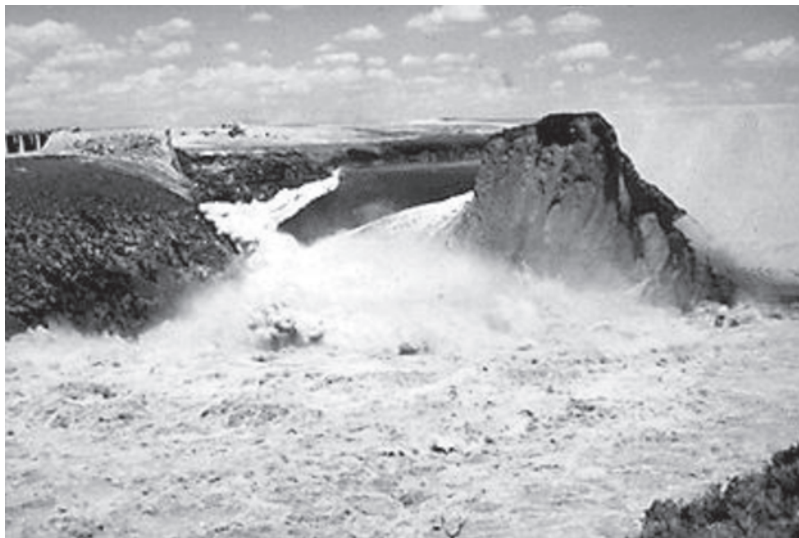
**Figure 1.2** Teton Dam collapse on 5 June 1976. (Reproduced with permission of U.S. Department of the Interior)

On Saturday, 5 June 1976, at 7:30 a.m., a muddy leak appeared, suggesting sediment was in the water, but engineers did not believe there was a problem. By 9:30 a.m., the downstream face of the dam had developed a wet spot erupting water at  $0.57\text{--}0.85 \text{ m}^3/\text{s}$ , and embankment material began to wash out. Crews with bulldozers were sent to plug the leak, but were unsuccessful. Local media appeared at the site, and at 11:15 a.m. officials told the county sheriff's office to evacuate downstream residents. Work crews were forced to flee on foot as the widening gap, now over the size of a swimming pool, swallowed their equipment. The operators of two bulldozers caught in the eroding embankment were pulled to safety with ropes. At 11:55 a.m., the crest of the dam sagged and collapsed into the reservoir, and 2 minutes later, the remainder of the right-bank third of the main dam wall disintegrated (see Figure 1.2). Over  $57\,000 \text{ m}^3/\text{s}$  of sediment filled water emptied through the breach into the remaining  $9.7 \text{ km}$  of the Teton River canyon, after which the flood spread out and shallowed on the Snake River Plain. By 8:00 p.m. that evening, the reservoir had completely emptied, although over two-thirds of the dam wall remained standing (see Figure 1.3).

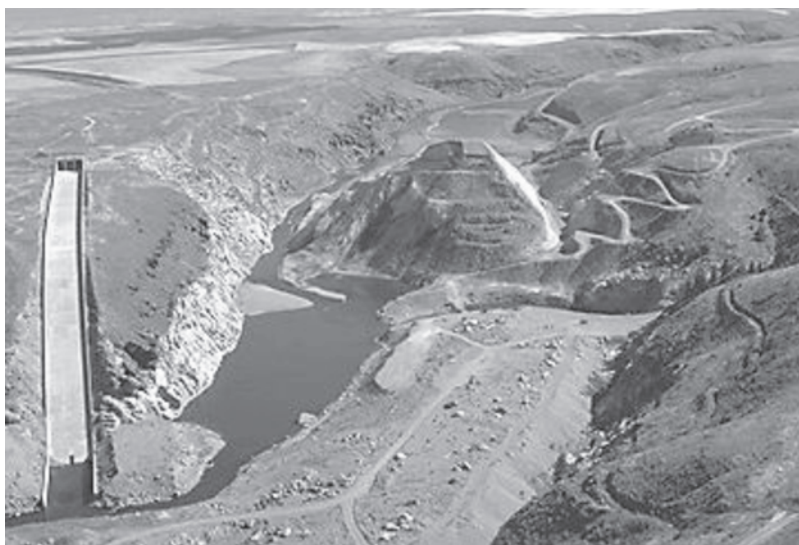
**Figure 1.3** View of the Teton Dam after collapse. (Reproduced with permission of U.S. Department of the Interior)

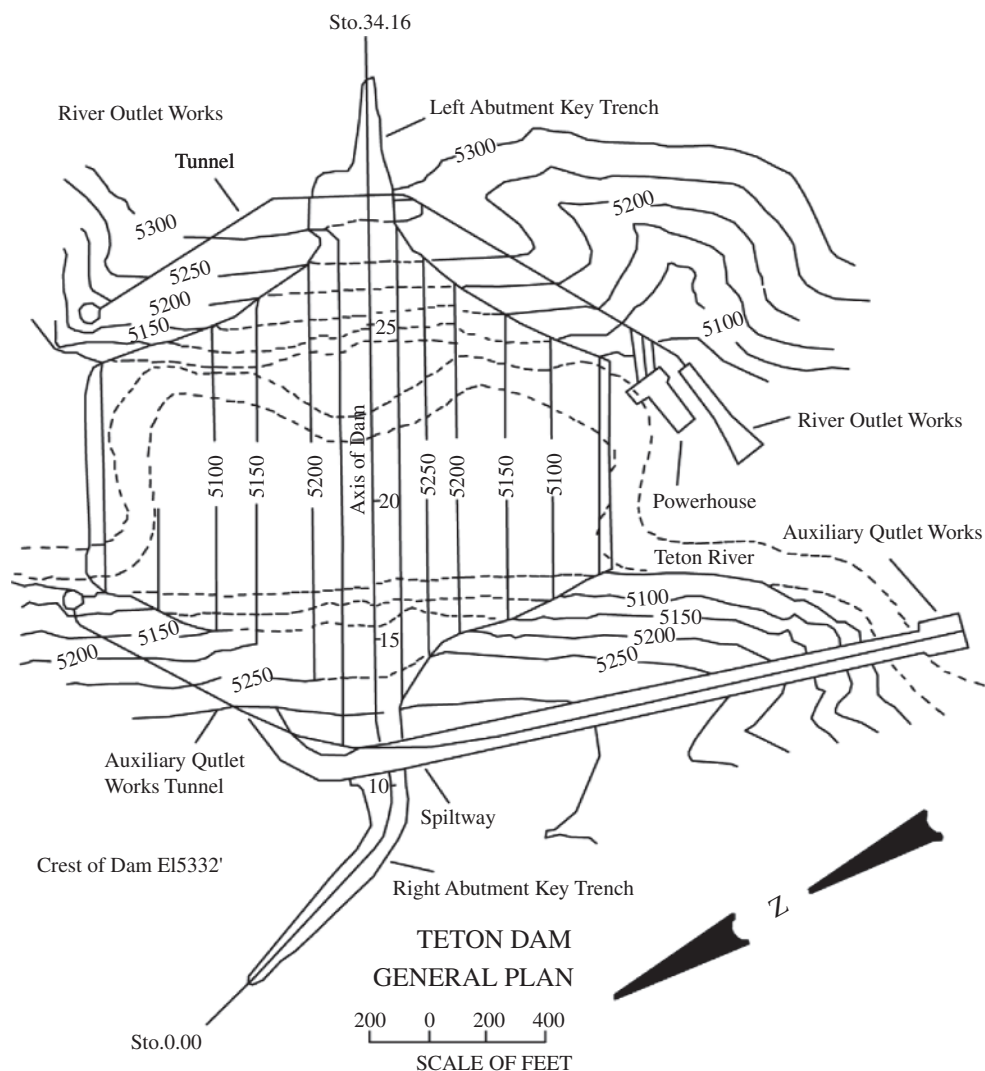
**Figure 1.4** General plan of the Teton Dam. (From Smalley, 1992. Reproduced with permission of *Geology Today*)

Study of the dam's environment and structure (see Figures 1.4 and 1.5) placed blame on the collapse of the permeable loess soil used in the core and on fissured (cracked) rhyolite in the foundations of the dam that allowed water to seep underneath. The permeable loess was found to be cracked. It is postulated that the combination of these flaws allowed water to seep through the dam and led to internal erosion (called *pip*ing)

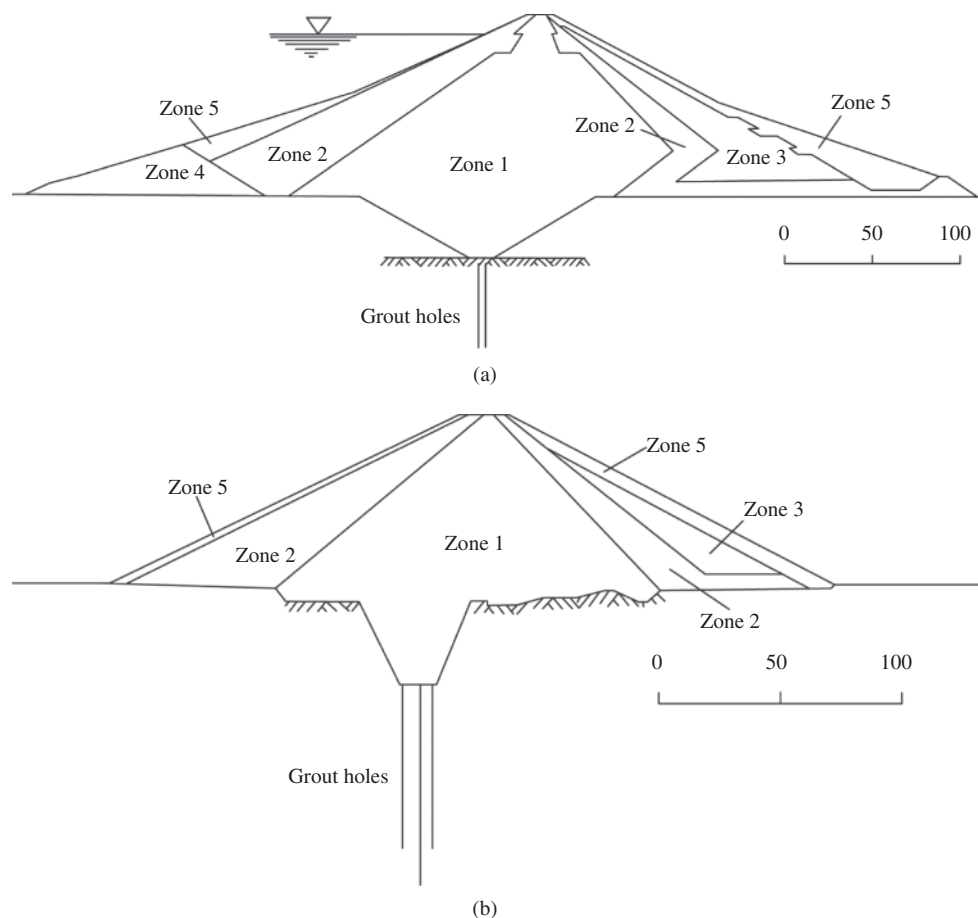
**Figure 1.5** Schematic cross sections of the Teton Dam (where Zone 1 is loess core zone; Zone 2 is selected sand, gravel; Zone 3 is miscellaneous fill; Zone 4 is selected silts, sand, gravel, and cobbles; and Zone 5 is selected gravel and cobbles). (a) Center section of embankment and (b) typical abutment section (from Smalley, 1992. Reproduced with permission of *Geology Today*)

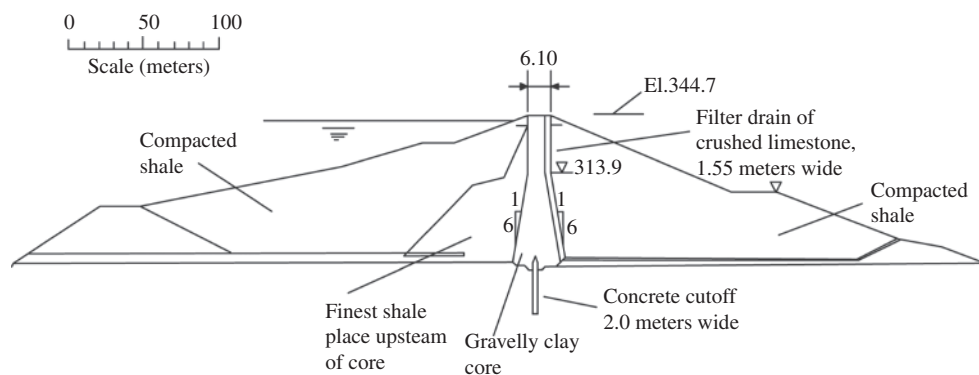
**Figure 1.6** Cross section of the Balderhead Dam. (From Sherard, 1973. Reproduced with permission of John Wiley & Sons, Inc.)

The Balderhead Dam, constructed in Co. Durham, England in 1961–1965, is an earth-rock fill dam with a narrow vertical soil core (Figure 1.6) and 48 m at its

The foundation was relatively incompressible. Over most of the length of the foundation was a shale. Portions of the shale length were overlain with a very stiff clay. The maximum thickness of the clay was about 18 m. The clay was left in place under the dam. A concrete cutoff wall with a 1.8 m width was sunk into the shale foundation. The cutoff wall was the full length of the dam in the center of the earth core. The width of the cutoff wall was 2 m (Figure 1.6) and the maximum depth of about 25 m (Figure 1.7).

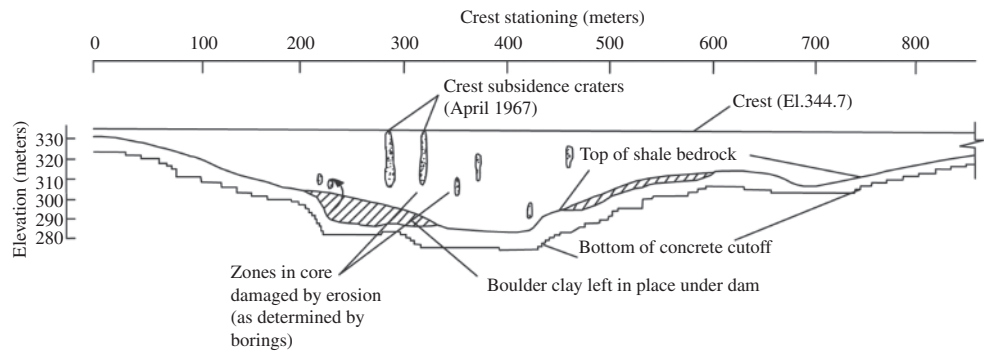
**Figure 1.7** Longitudinal section and location of erosion damage zones in core of the Balderhead Dam. (From Sherard, 1973. Reproduced with permission of John Wiley & Sons, Inc.)

seepage from the main under-drain for the full length of dam was about 10 l/s. In January 1966, as the reservoir reached its maximum level, the measured seepage dropped suddenly to 5 l/s for a few days and then abruptly increased again to about 35 l/s by the end of February 1966. Between March and August 1966, the measured leakage was roughly constant at 25 l/s. In August 1966, the measured leakage started to increase again, and to fluctuate considerably, reaching a maximum of about 55 l/s by the end of December 1966, when it abruptly fell to about 30 l/s. At the end of January 1967, a small depression was discovered on the downstream edge of the crest at Station 266. At the beginning of April 1967, a larger subsidence crater, about 3.0 m in diameter and 2.5 m in depth, developed on the upstream edge of the crest at Station 317 (Figure 1.7).

Numerous zones of erosion damage were encountered in the core (Figure 1.7). The samples, which were obtained in these damaged zones, and consisted primarily of the coarser particles of the core material, showed that the leakage through the core had washed out the fines. Figure 1.9 shows the best interpretation from the borings of the extent of the damaged zone at Station 317.

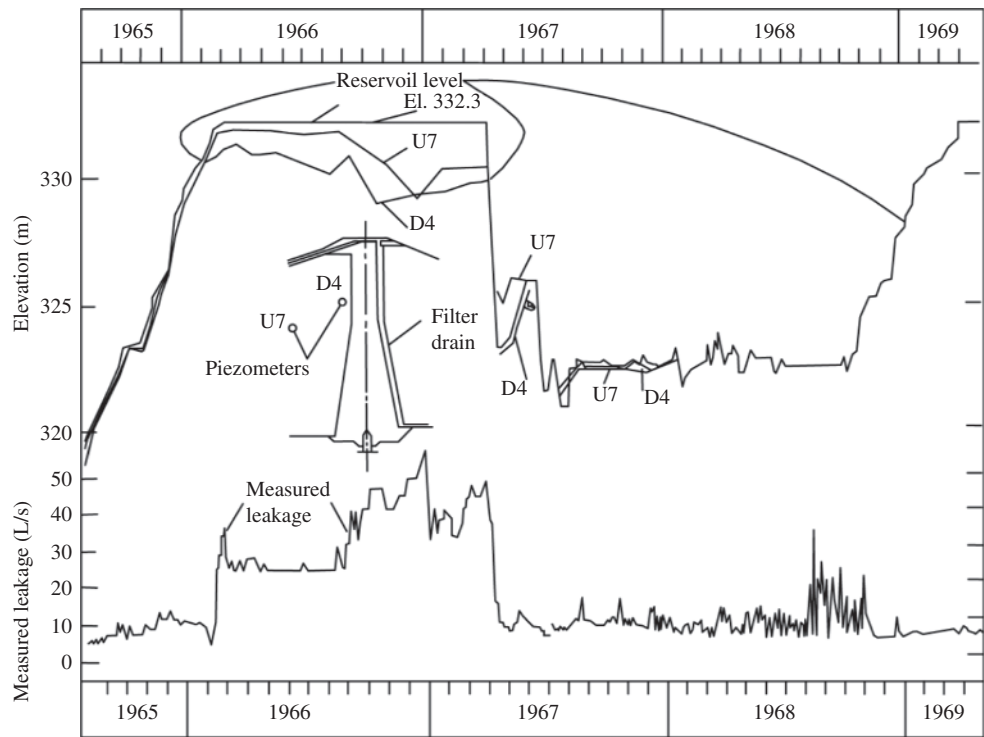
**Figure 1.8** Reservoir level, measured leakage, upstream piezometer readings from the Balderhead Dam. (From Sherard, 1973. Reproduced with permission of John Wiley & Sons, Inc.)

Reservoir filling commenced in October 1964, and the water level rose relatively slowly to its maximum elevation by February 1966 and remained there until March 1967 (Figure 1.8). As the reservoir was rising in the fall of 1965, the total measured

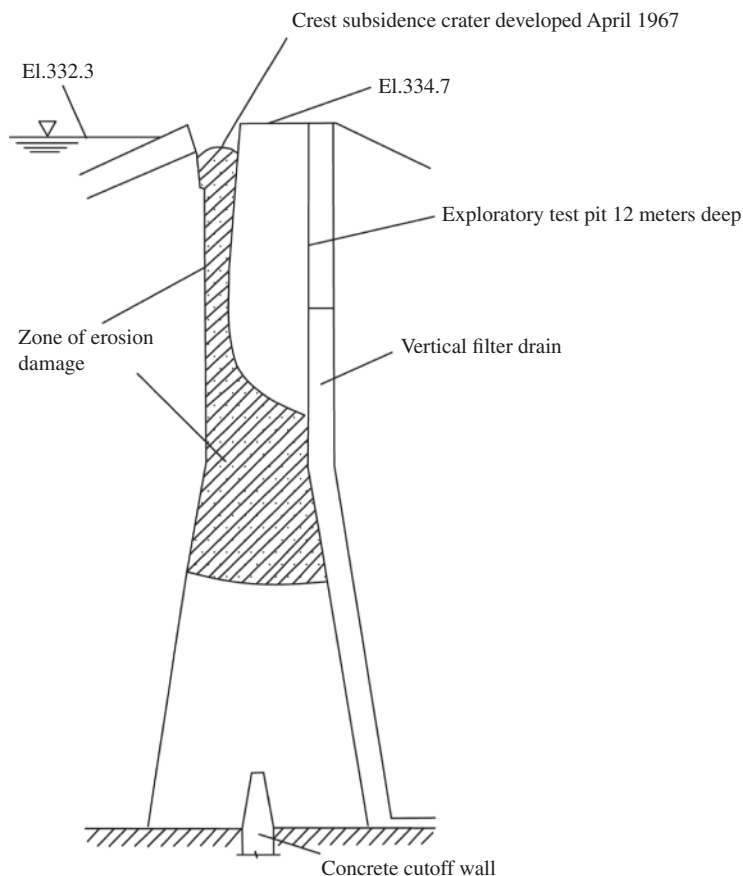
**Figure 1.9** Estimated zone of erosion damage in dam core at Station 317 of the Balderhead Dam. (From Sherard, 1973. Reproduced with permission of John Wiley & Sons, Inc.)

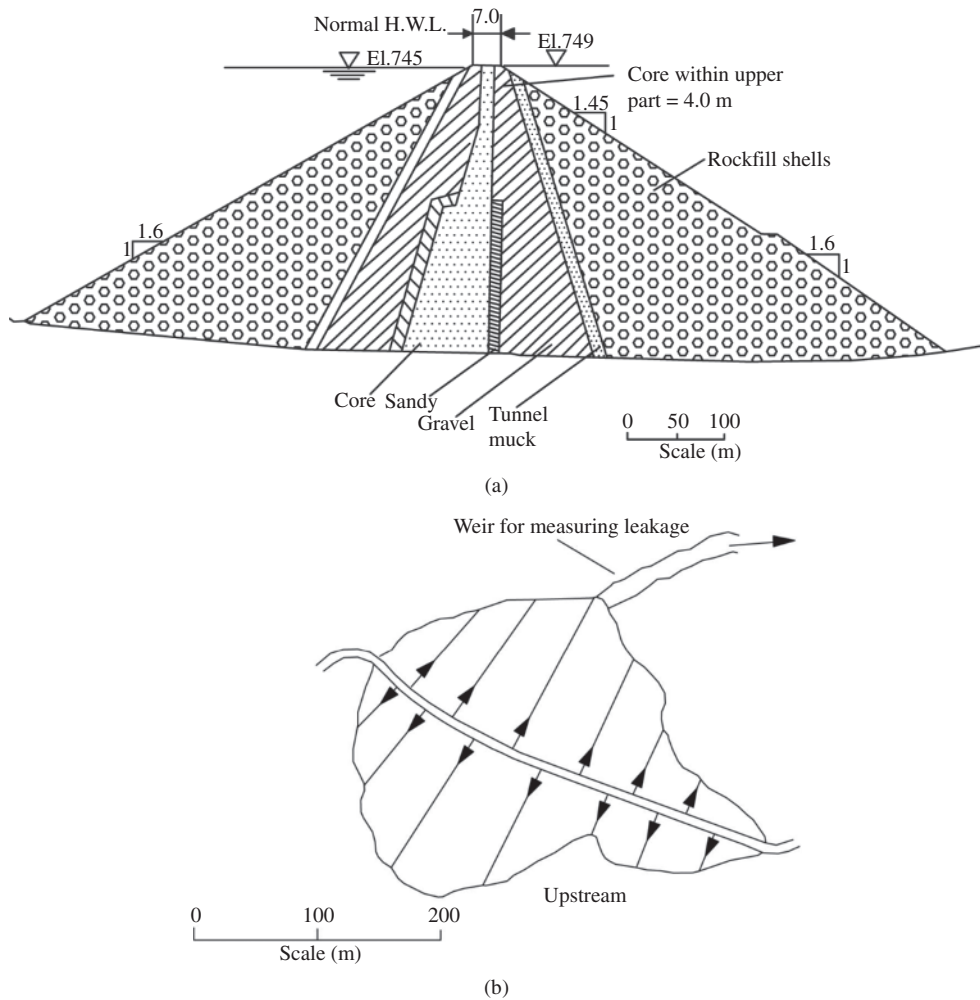
**Figure 1.10** Hyttejuvet Dam. (a) Cross section and (b) general plan. (From Sherard, 1973. Reproduced with permission of John Wiley & Sons, Inc.)

The Hyttejuvet Dam, 90 m in height and 400 m in crest length, was constructed in 1964–1965 in Norway. It has a thin vertical-sided central earth core, two rock-fill shells, and two thick gravel transition zones (Figure 1.10). During the first reservoir filling in the summer of 1966, a concentrated leak of dirty water emerged abruptly at the downstream toe when the reservoir was nearly full. Investigations led to the conclusion that the leak developed through a horizontal differential settlement crack, and that the crack resulted from the arching action of stress in the core. The core was constructed using a clayey sand compacted in 25 cm thick layers. At the end of the 1964 construction season, when the dam was about mid-height, the design was changed and the core was made much thinner, as shown in Figure 1.10(a). The change was made because the construction pore pressures being measured in the core were higher than those anticipated.

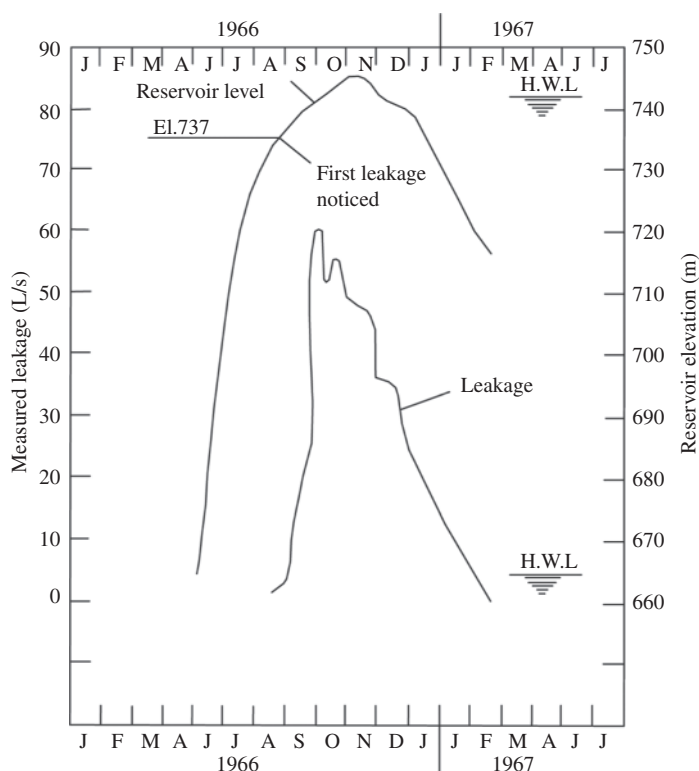
**Figure 1.11** Reservoir level and measured leakage 1966–1967 of Hyttejuvet Dam. (From Sherard, 1973. Reproduced with permission of John Wiley & Sons, Inc.)

The reservoir was filled rapidly for the first time starting in May 1966. As seen in Figure 1.11, very little leakage (less than 2 l/s) appeared at the downstream toe until the middle of August 1966, when the reservoir level had reached to within 7 m of the high water level (Elevation 737). As the reservoir was raised above this level in the last 15 days in August, the leakage increased abruptly, and reached a maximum of about 63 l/s by the end of August, when the reservoir had reached approximate Elevation 740. The leakage water, measures with a weir at the downstream toe (Figure 1.10b), was gray colored and contained approximately 0.1 g of fines per liter. At the beginning, it was not clear that the dirty flow was caused by piping of the core. This is because the water could have been picking up fines as it passed through the rock-fill

before emerging at the downstream toe. Later, primarily because of the persistence of the dirty leakage, the investigators concluded that most of the turbidity was caused by piping of the core. During September and early October 1966, the reservoir rose gradually another 5 m to the high-water level. During this time, the measured leakage decreased from about 62 to 45 l/s (Figure 1.11).

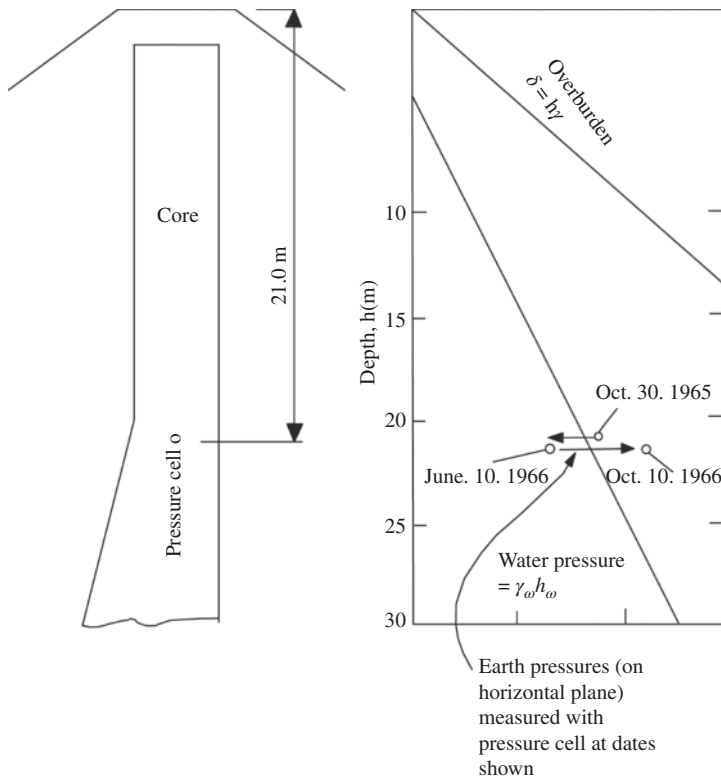
**Figure 1.12** Measurement of earth pressure in core of Hyttejuvet Dam. (From Sherard, 1973. Reproduced with permission of John Wiley & Sons, Inc.)

During the construction of the dam, in order to measure total vertical stress, a single earth pressure cell was installed in the center of the core 21 m below the dam crest, or 17 m below high-water level. As shown in Figure 1.12, at the end of construction, the pressure measured by the cell was around 17 tons/m<sup>2</sup> on 30 October 1965. The pressure decreased to about 14 tons/m<sup>2</sup> by June 1966 and increased again to about 23 tons/m<sup>2</sup> when the reservoir was full in mid-October 1966. These measurements made it seem probable that an appreciable portion of the total weight of the core had been transferred to the shells by arching action.
